Manhole Inspection Summary

Manhole # S11QQ1006MH

Insp Date: **4/27/07 11:05 AM**

Location Address: **5000 PIMLICO ROAD**

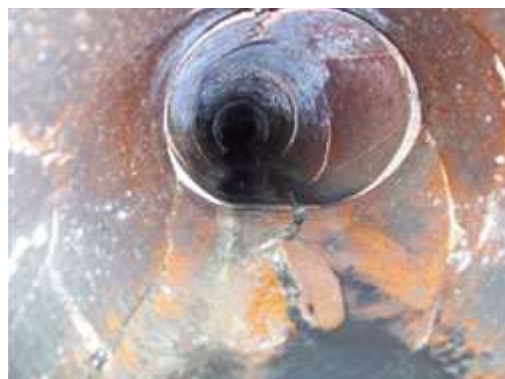
Defect 2

CRACKED PIPE, FIRST 6 FEET

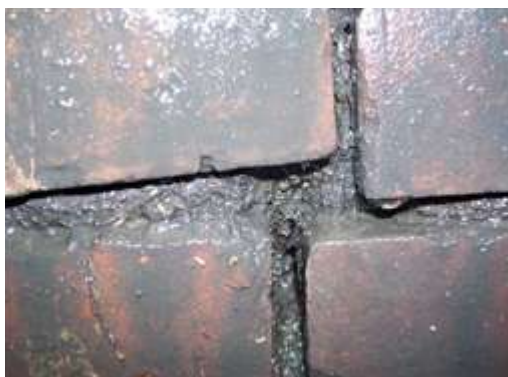
Defect 1

Infiltration: ☐ None ☐ Joint ☐ Cracks ☐ Mortar ☐ Roots ☒ **Wall**

BARREL- MISSING/ DETERIORATED
MORTAR-INFILTRATION

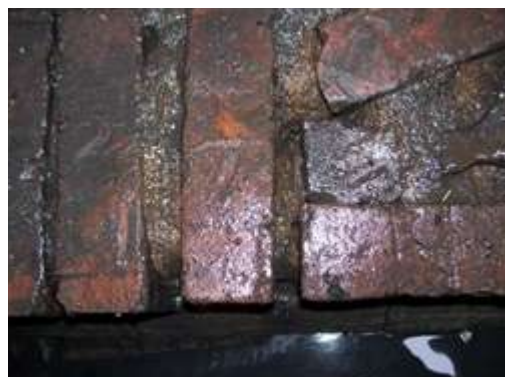
Defect 3

MISSING AGGREGATE - BENCH

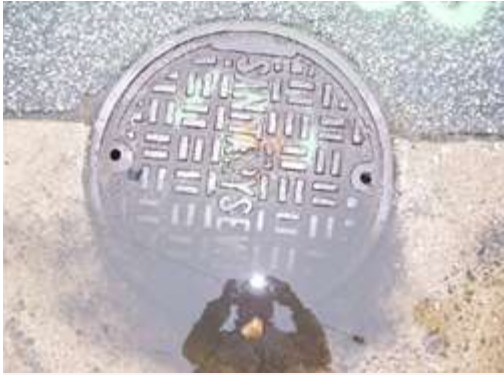
Subject To Ponding: **Ponding**

AREA SUBJECT TO PONDING AND SHEETING

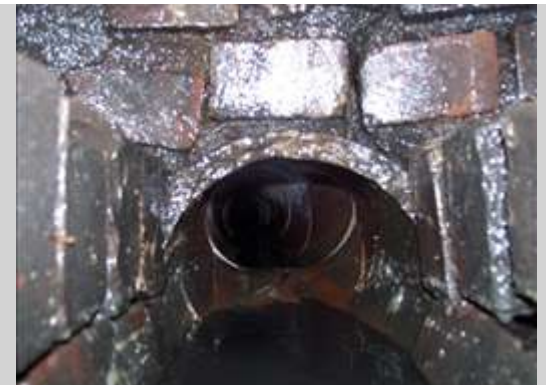
6 O'Clock Inflow

CRACKED PIPE, FIRST 6 FEET

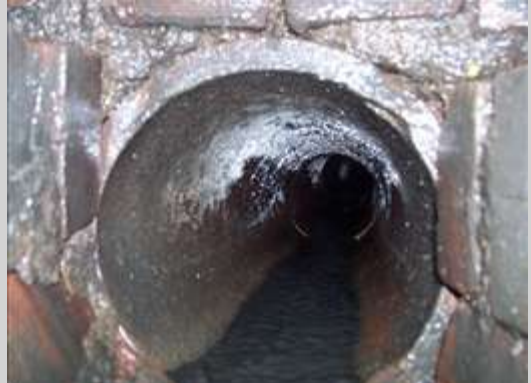
9 O'Clock Inflow

CRACKED PIPE, FIRST 6 FEET
